Circle Ridge/Coal Draw near NPDES point (CR-7.5)

Circle Ridge/Coal Draw at bridge Site CR-8

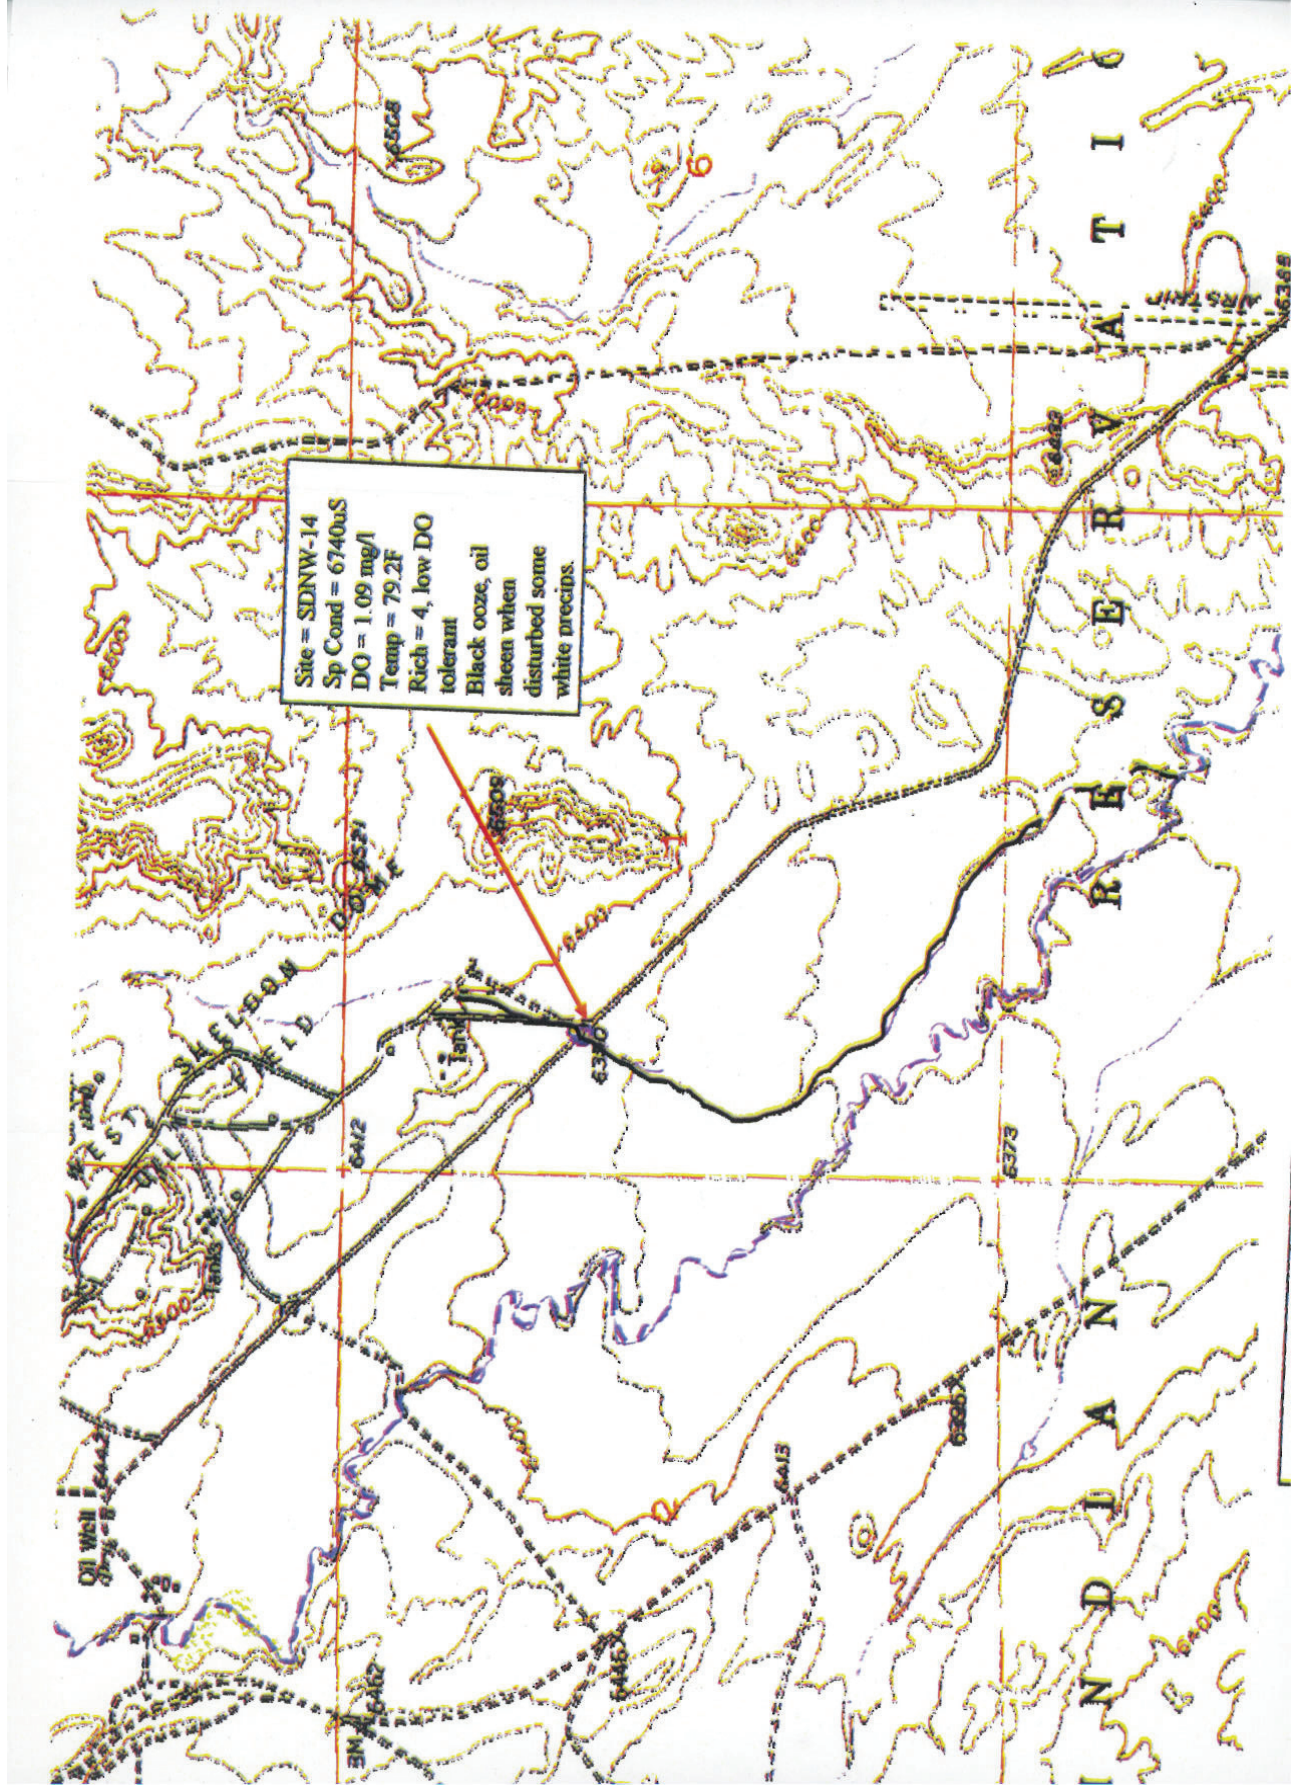
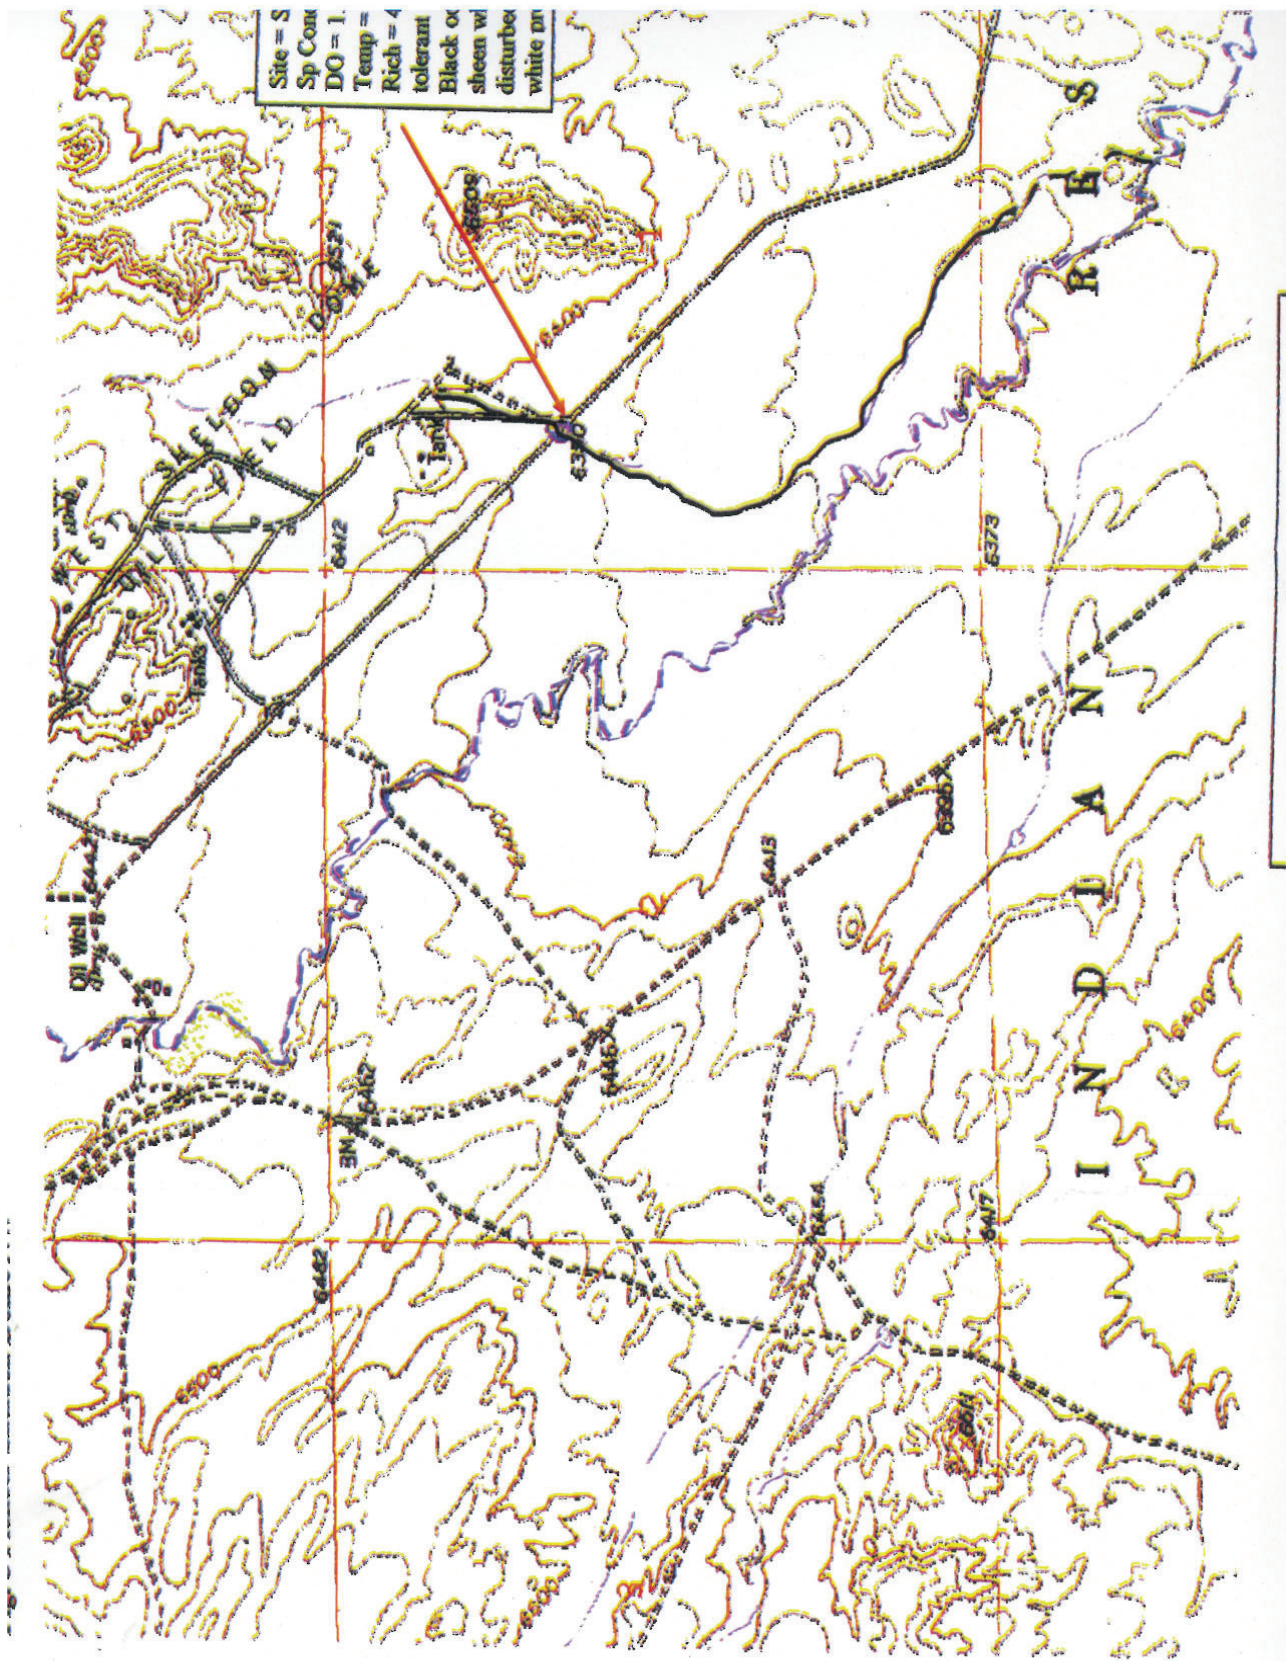
Four species of macroinvertebrates were found in low numbers and all are tolerant of high TDS and low DO. The *Brachycercus* mayflies were adults that could have lived as nymphs elsewhere and were attracted to this water segment for swarming purposes.

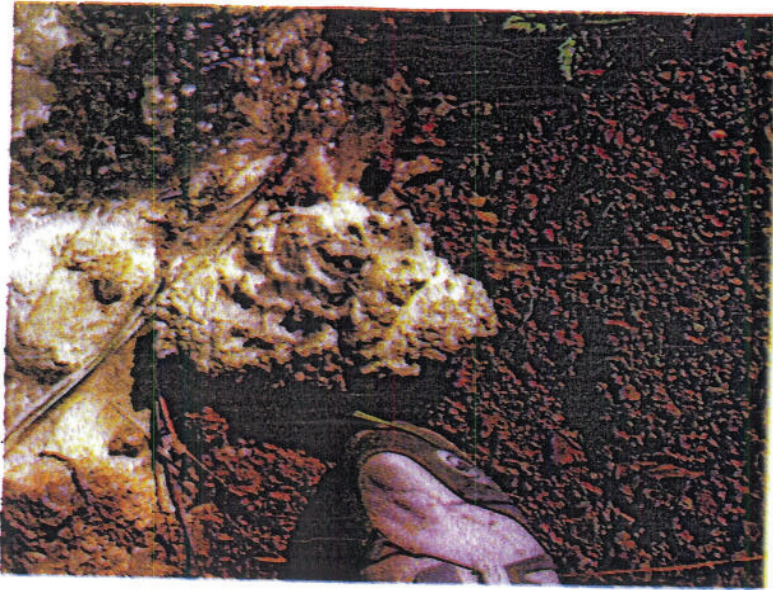
CR7.5-2: Barium sulfate is relatively insoluble and forms white precipitates on the bottom and along the edges of the stream.

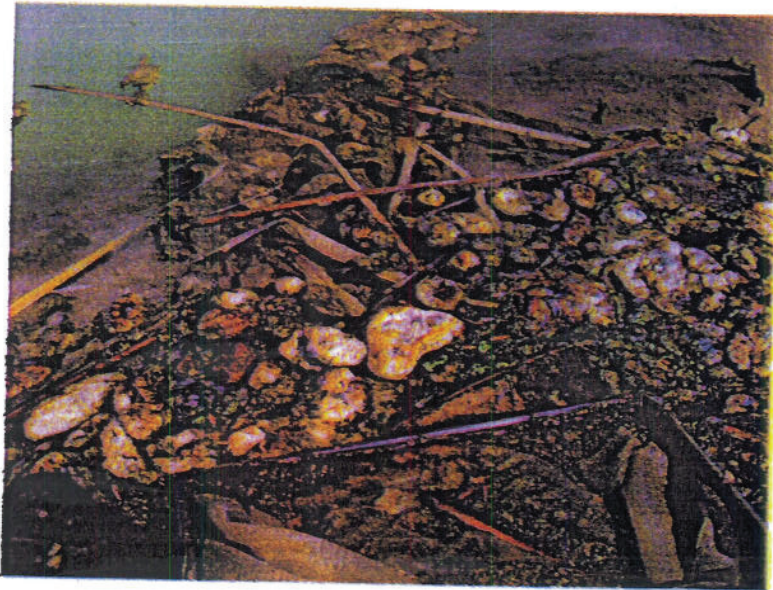
The oxygen was 4.77 mg/l on Aug. 09, 05. Four species of macroinvertebrates that were found all breathe atmospheric oxygen and are tolerant of low DO conditions. The oxygen was relatively high when sampled (4.77 mg/l) but the low DO tolerant macroinvertebrates indicate that much lower DO's have probably been encountered in the past. These macroinvertebrates are found in ponds and the pools of the stream where they can come to the surface to get the atmospheric oxygen.

CR7.5-3: Atmospheric breathing macroinvertebrates such as rat-tail maggots and Dytiscid beetles live in ponds and slow moving pools.

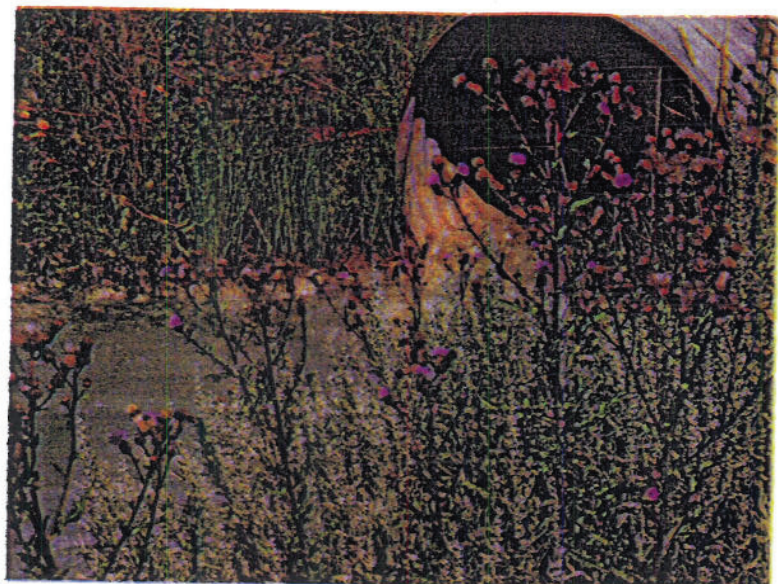
The white barium sulfate precipitates cover both the gravel and sand substrates in the faster water and the black sapropel ooze at the edges and slower water. Some precipitate-covered macrophyte beds (*Chara*) were observed and probably aide in adding oxygen to the water through photosynthesis. The water is still a milky white color but not as dense as nearer as site CR-7.5 and nearer the discharge point. Barium was 857 ug/l and the sulfides were still very high at 26,400 ug/l. Both of these are a concern. This stream segment is tentatively considered as partially supporting of its aquatic life use, but the toxic water chemistry screen done at the NPDES outfall will aide in this evaluation.

CR8-1: The water was still a white milky color at the bridge, but not as turbid as the upper site.
